TECHNICAL MEMORANDUM

Date: October 31, 2022
To: Akin Okupe, EPASD General Manager
From: Jeffrey C. Bensch, P.E.
Cc:

**RE: CCTV Survey Results Evaluation and Pipeline Replacement Priorities
Areas 1, 3, and 4**

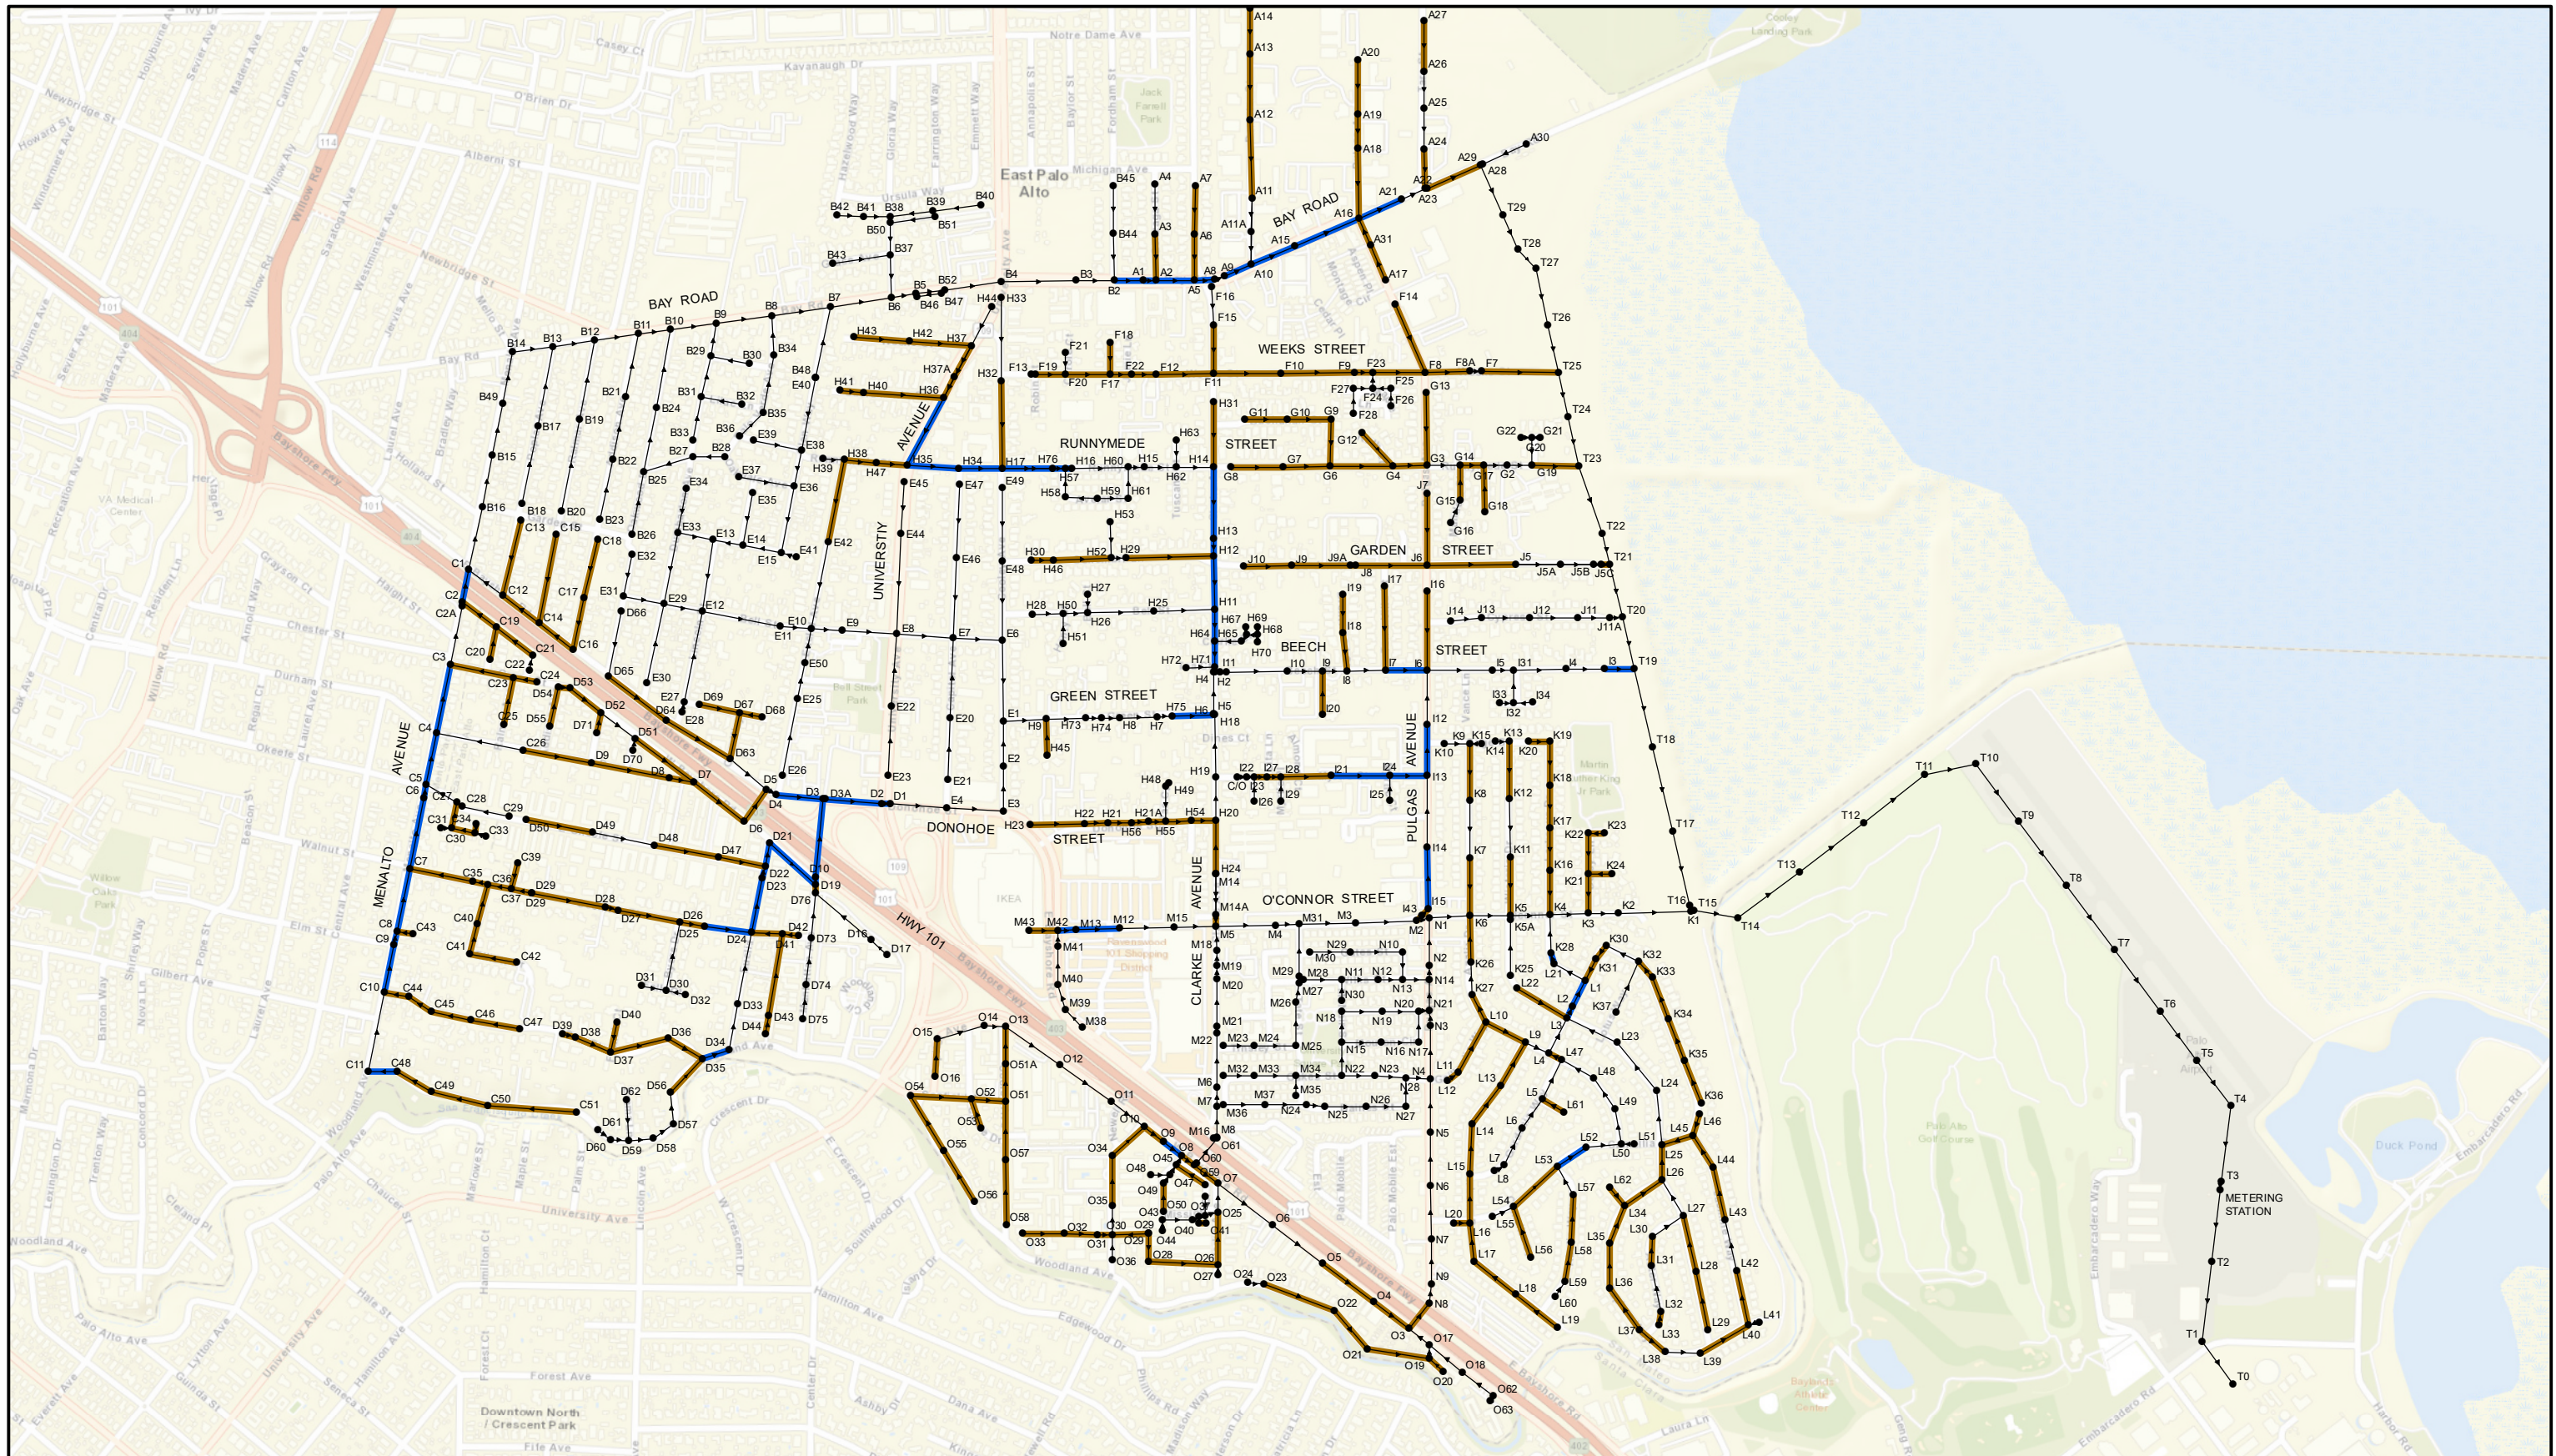
The Structural, Notable Defects, and Sagging scores are added to create the Total Score for each pipeline segment. The Total Scores are ranked from highest to lowest to generate a priority list of pipelines to replace (Table 1). Pipelines with a score greater than 25 from each Area were selected as the group with significant structural defects needing replacement. A geographic information system (GIS) was used to generate Figure 2 showing the pipelines that need to be replaced to resolve structural defects in Areas 1, 3, and 4.

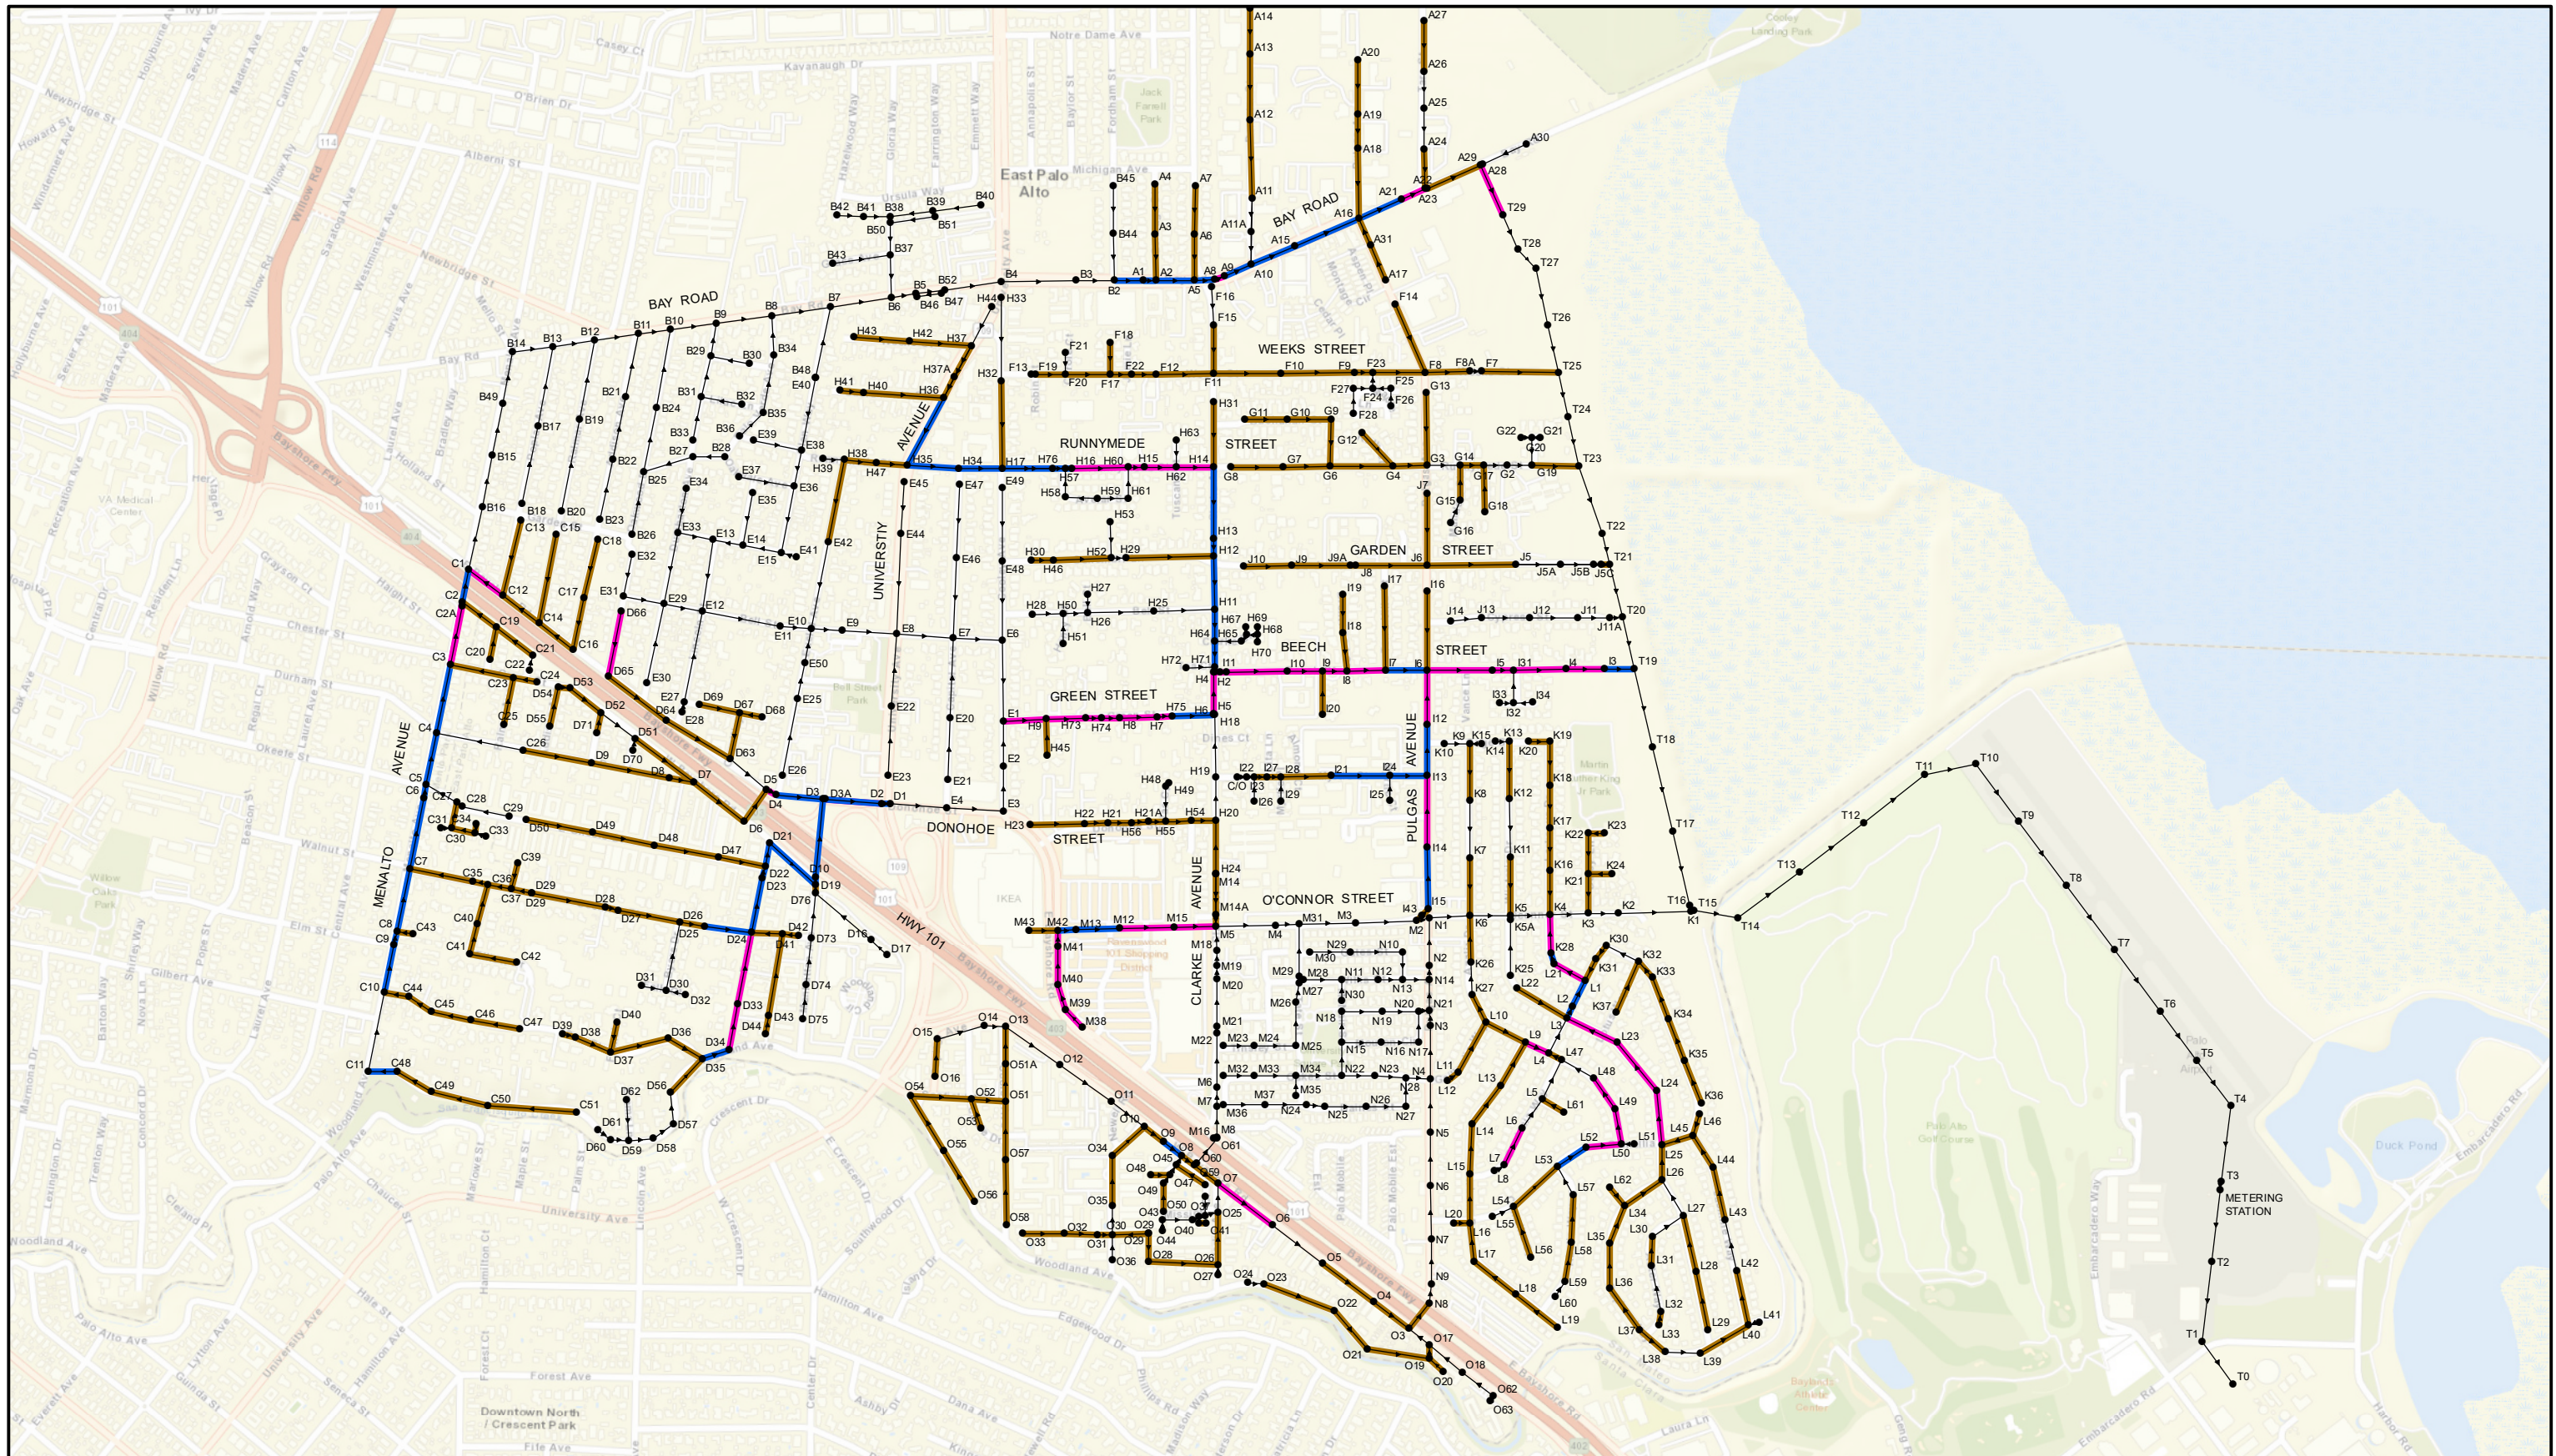
The Structural, Notable Defects, and Sagging scores, and the Capacity score, are added to create the Total Score for each pipeline segment. The Total Scores are ranked from highest to lowest to generate a priority list of pipelines to replace. Pipelines with a Total Score greater than 25 were selected as pipelines for replacement (Table 4). The GIS was used to generate Figure 3 showing the pipelines that need to be replaced to resolve structural defects and capacity inadequacies in Areas 1, 3, and 4.

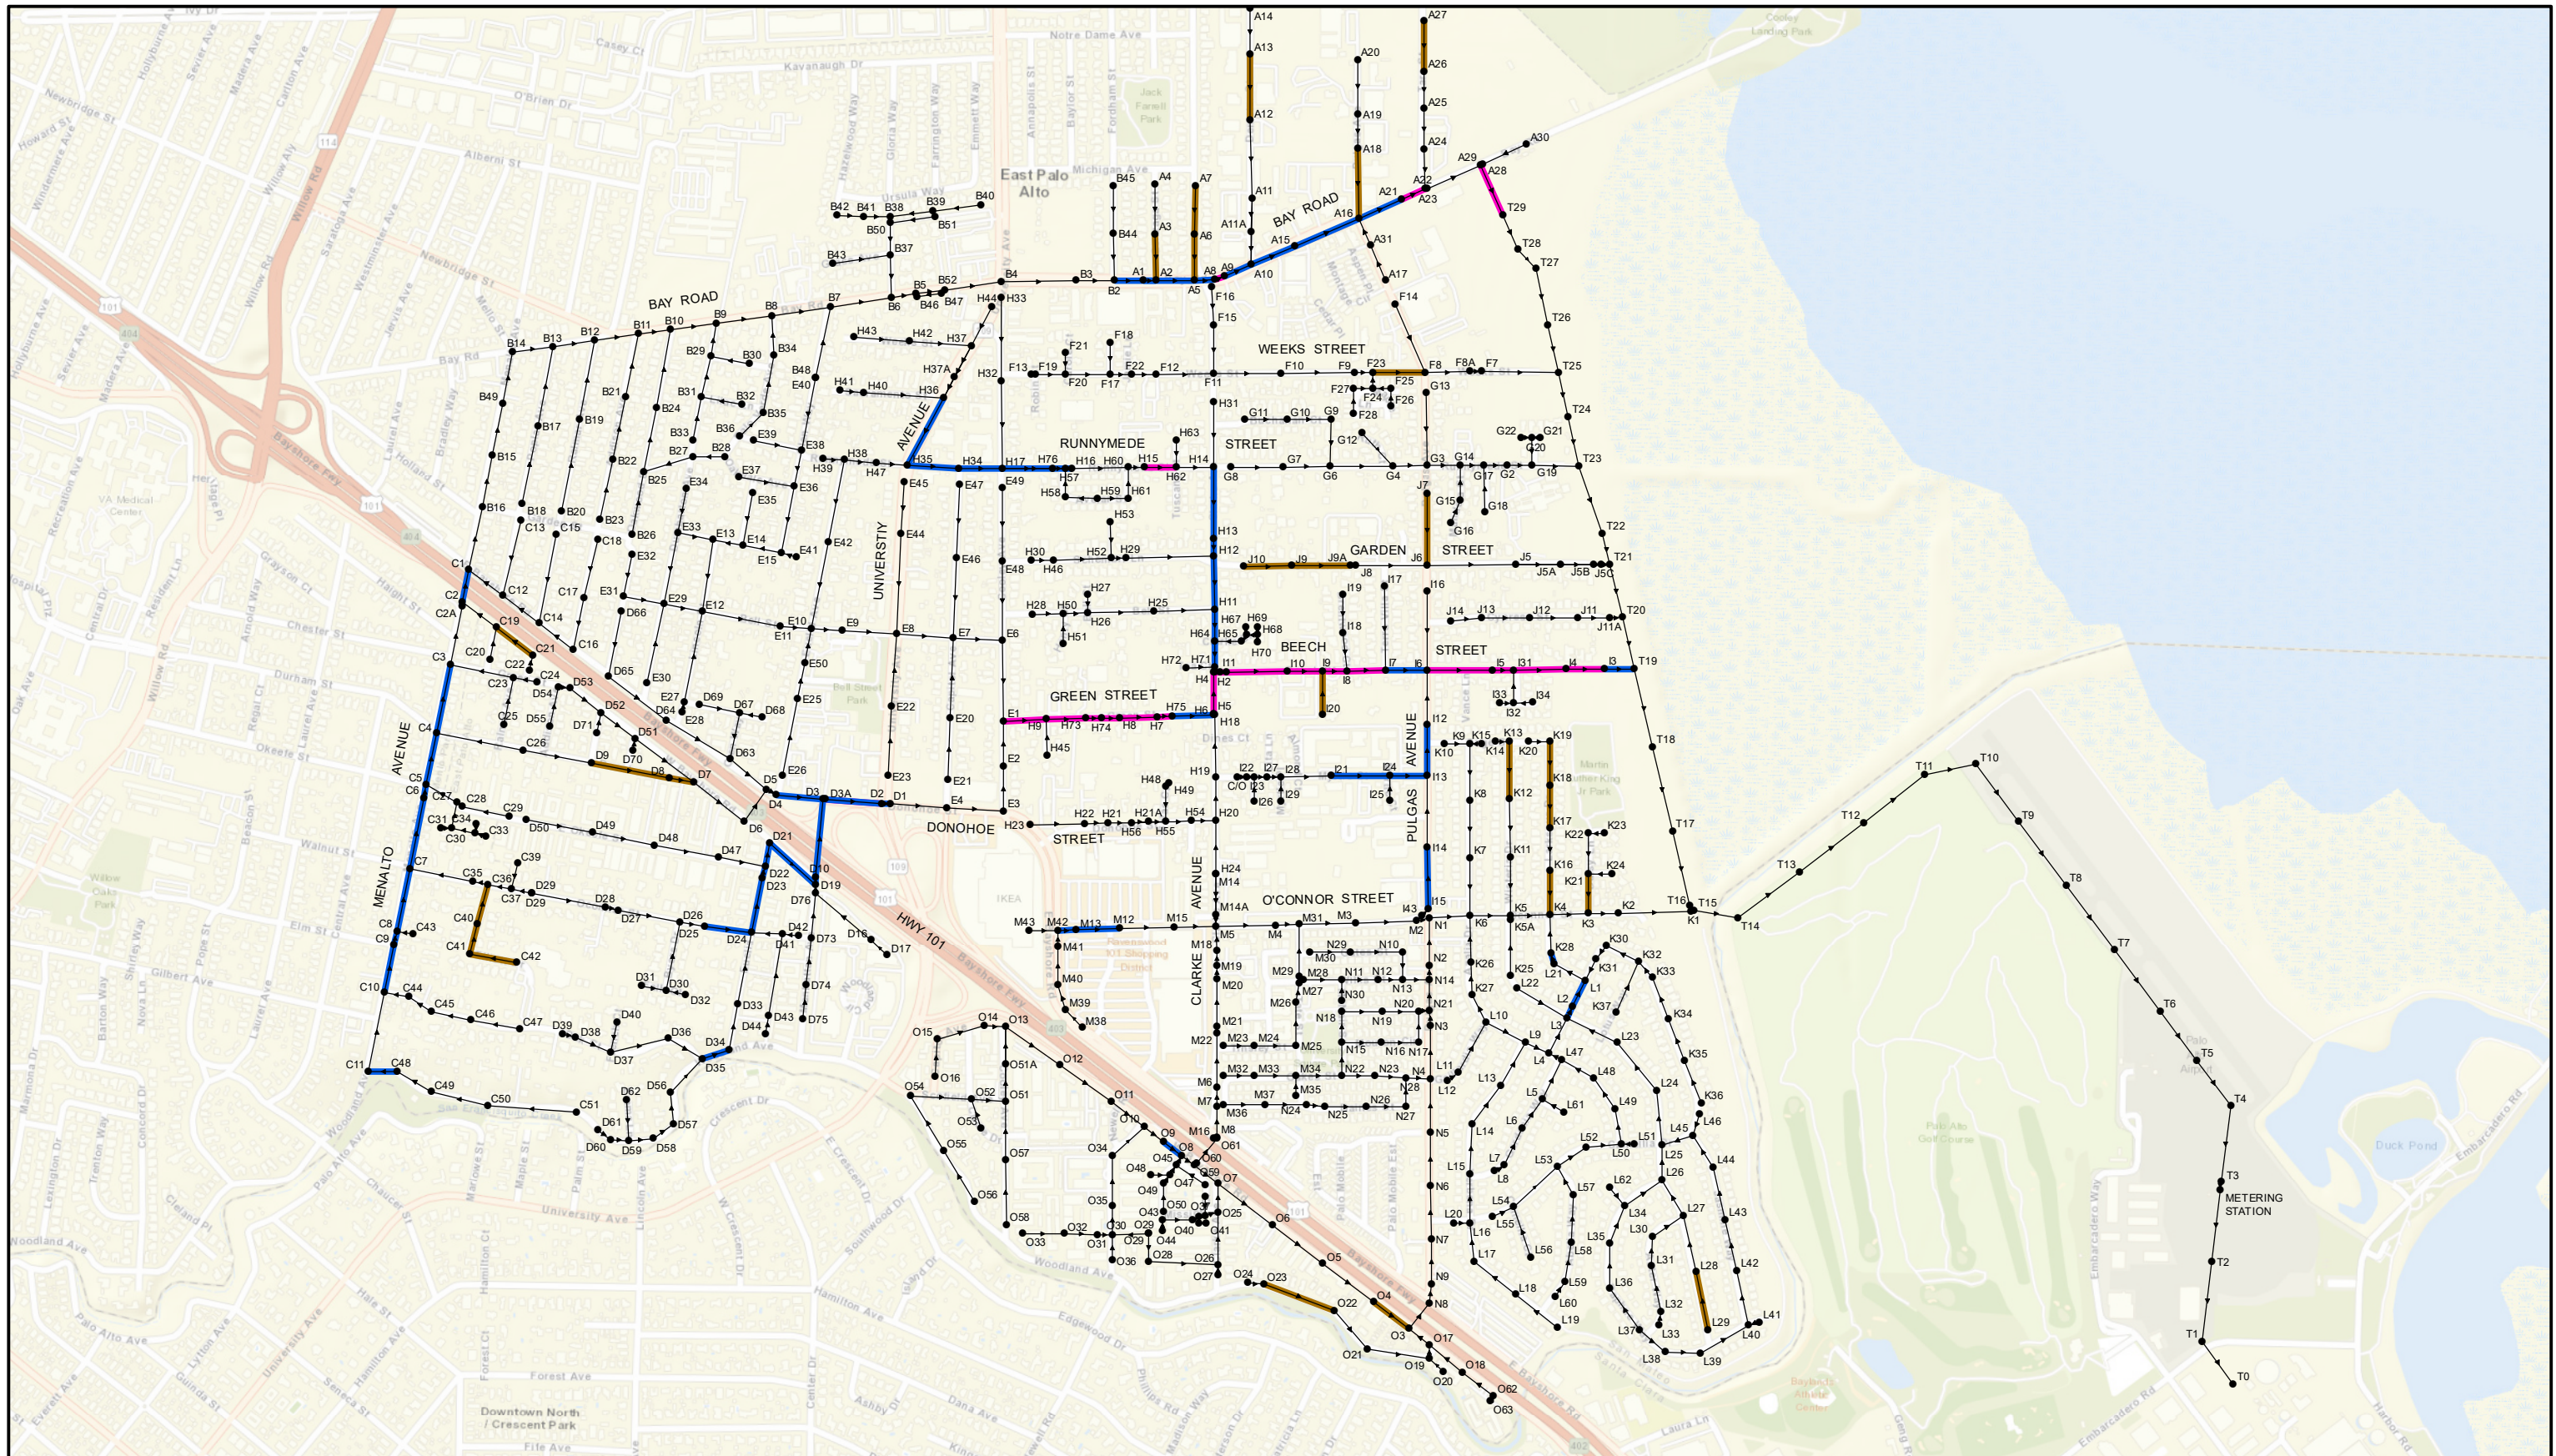
Pipeline segments with a Total Score greater than 75 were selected as the group of pipelines to be replaced (Table 7). A geographic information system (GIS) was used to generate Figure 4 showing the pipelines that need to be replaced.
