**California American Water
Monterey District**

East Palo Alto Area

**Gloria Way Well
Investigation Summary
Report**

April 2004

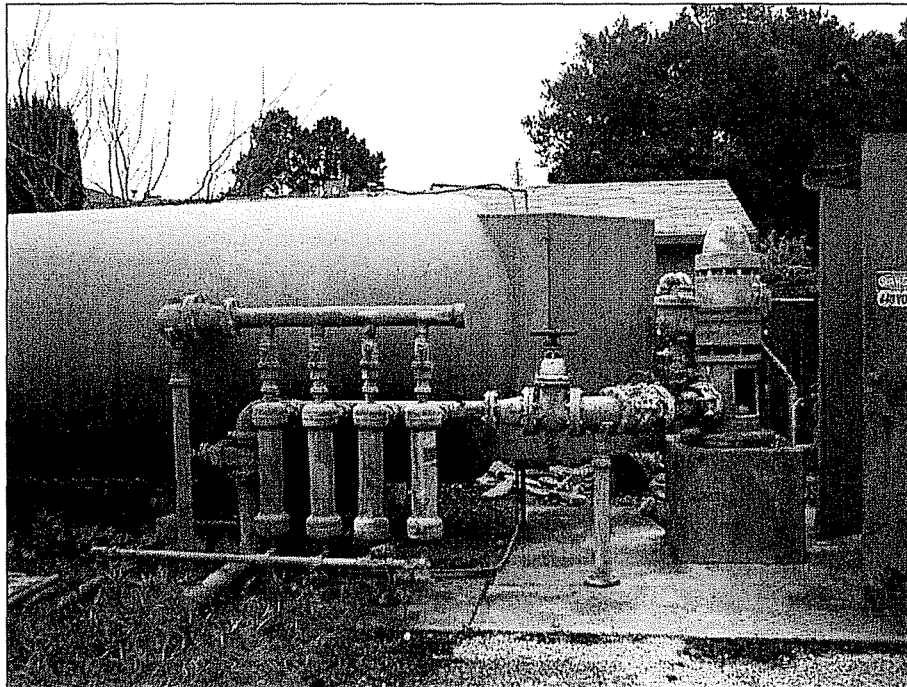
The work performed included the performance of a constant discharge test to assess the well's performance characteristics. The work also included the physical inspection of the well and pump. The well is located at the intersection of Gloria Way and Bay Street in East Palo Alto. The well is shown in the picture below.

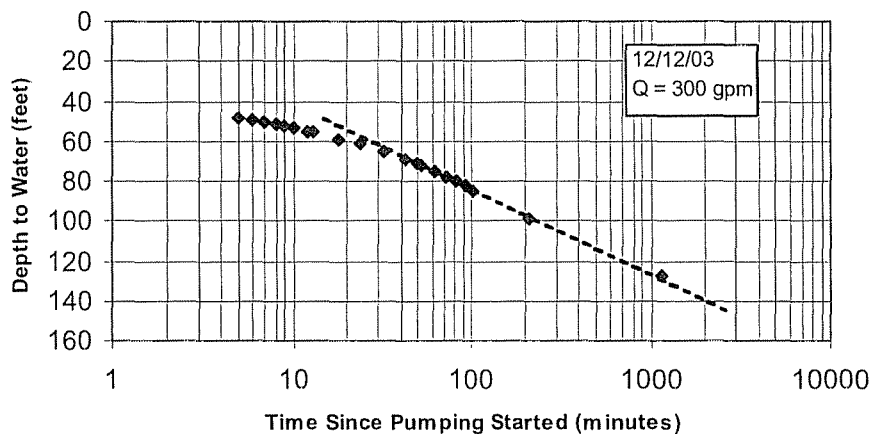
FIGURE 1 – Gloria Well – Constant Discharge Test

As shown on Figure 1, water level declined from static to approximately 55 feet after 10 minutes. Then, as casing storage was depleted, water level decline steepened, falling along a conventional semi-logarithmic line with the pumping level at approximately 85 feet after 100 minutes and at 125 feet after 1,000 minutes. Utilizing the projected pumping level at 24-hours of 130 feet results in a 24-hour specific capacity¹ of 2.6 gpm/ft.

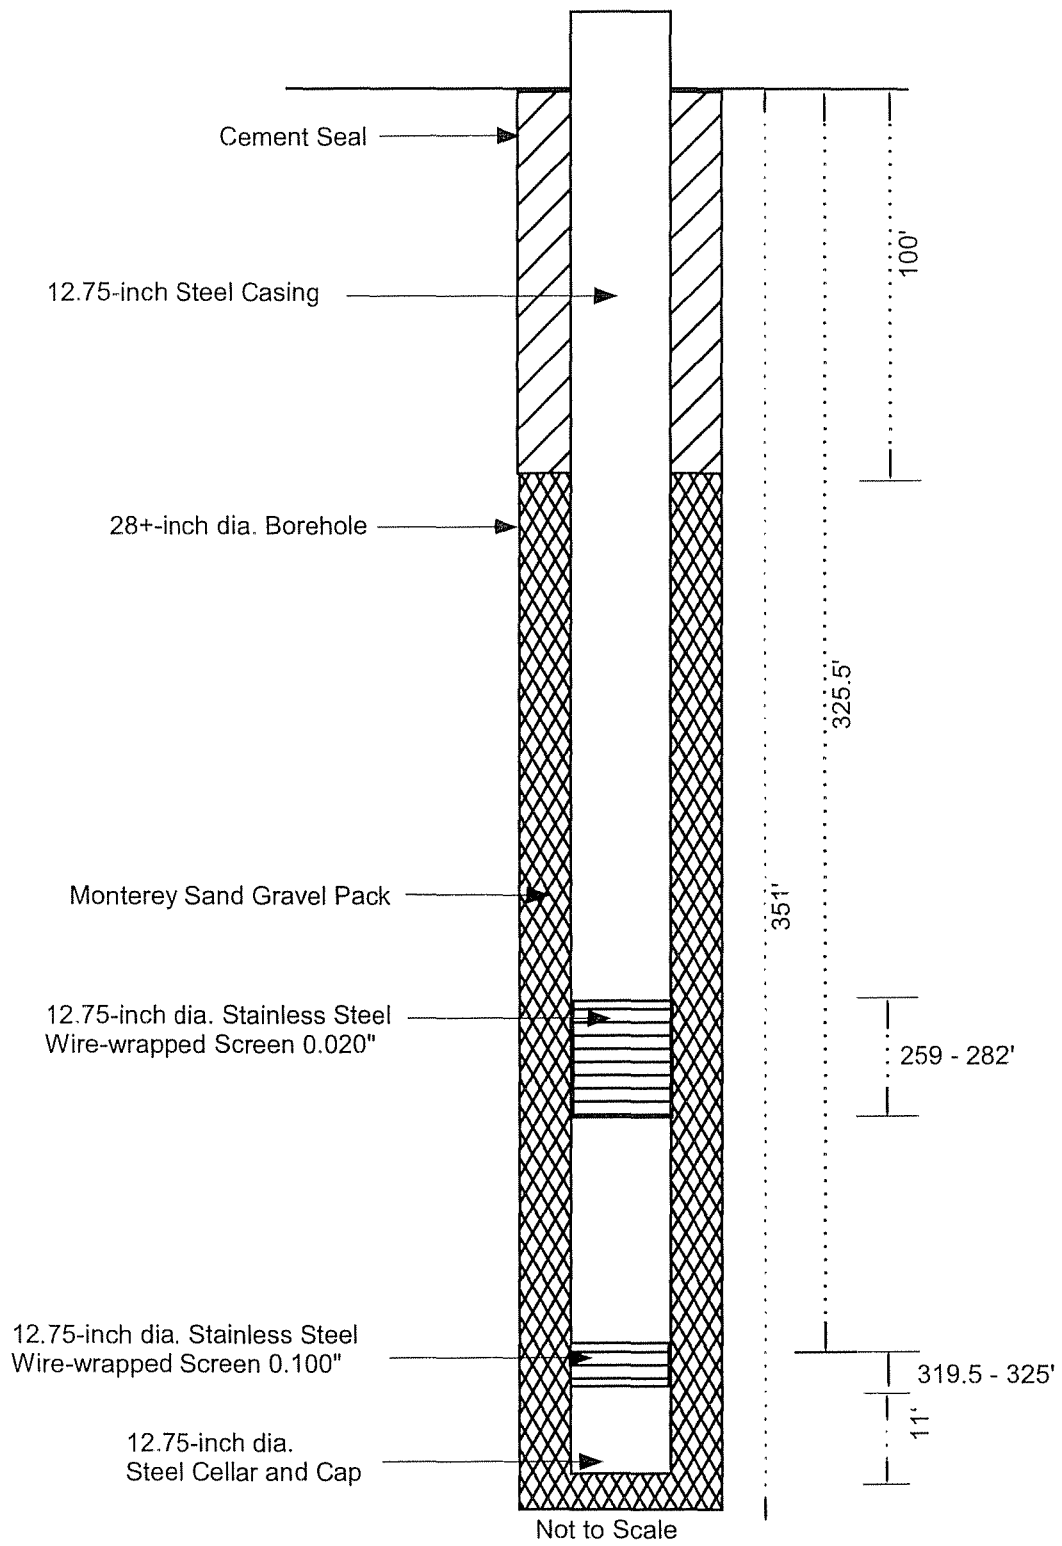
**Figure 1 - Well Schematic
"as-built" Gloria Way Well
East Palo Alto**

Data from the video survey allows documentation of the "as-built" well². Well is constructed of what appears to be 12 ¾ -inch diameter spiral weld mild steel casing. The blank casing is in very good condition. Perforated intervals are 12 ¾ -inch diameter stainless steel wire-wrapped screen. No evidence of galvanic isolation couplings were visible. Perforations were visible in the intervals from 259 – 282 and 319.5 – 325 feet below ground surface. These screen placements are generally consistent with the depths reported on the drillers' logs. However, the upper screen, as reported and as placed, does not align well with the available water bearing materials. Fine sand is reported in the interval between 250 and 269 feet whereas the screen is set between 259 and 282 feet. Above and below the sand are clay materials. The lower screen aligns with the 6 feet of sand and gravel reported between 319.5 and 325.5 feet. Bottom of the well was encountered at 333.5 feet and compares well to the reported bottom of 334 feet suggesting minimal fill. An as-built schematic of the well is presented as Figure 2 – Well Schematic.

Construction details taken from Drillers
Log as corrected by Video Survey
