**Project:** #B11689; 1950 Bay Road

SCA Environmental, Inc. (SCA) conducted a *Phase I Environmental Site Assessment* on behalf of the John & Marcia Goldman Foundation (JMGF) for the proposed East Palo Alto Youth Center project site located in East Palo Alto, California (hereafter referred to as the “Target Property”, Figures 1 and 2).

<b>VICINITY MAP</b> Proposed East Palo Alto Youth Center East Palo Alto, California SCA Project No.: B11689	Figure <b>1</b>

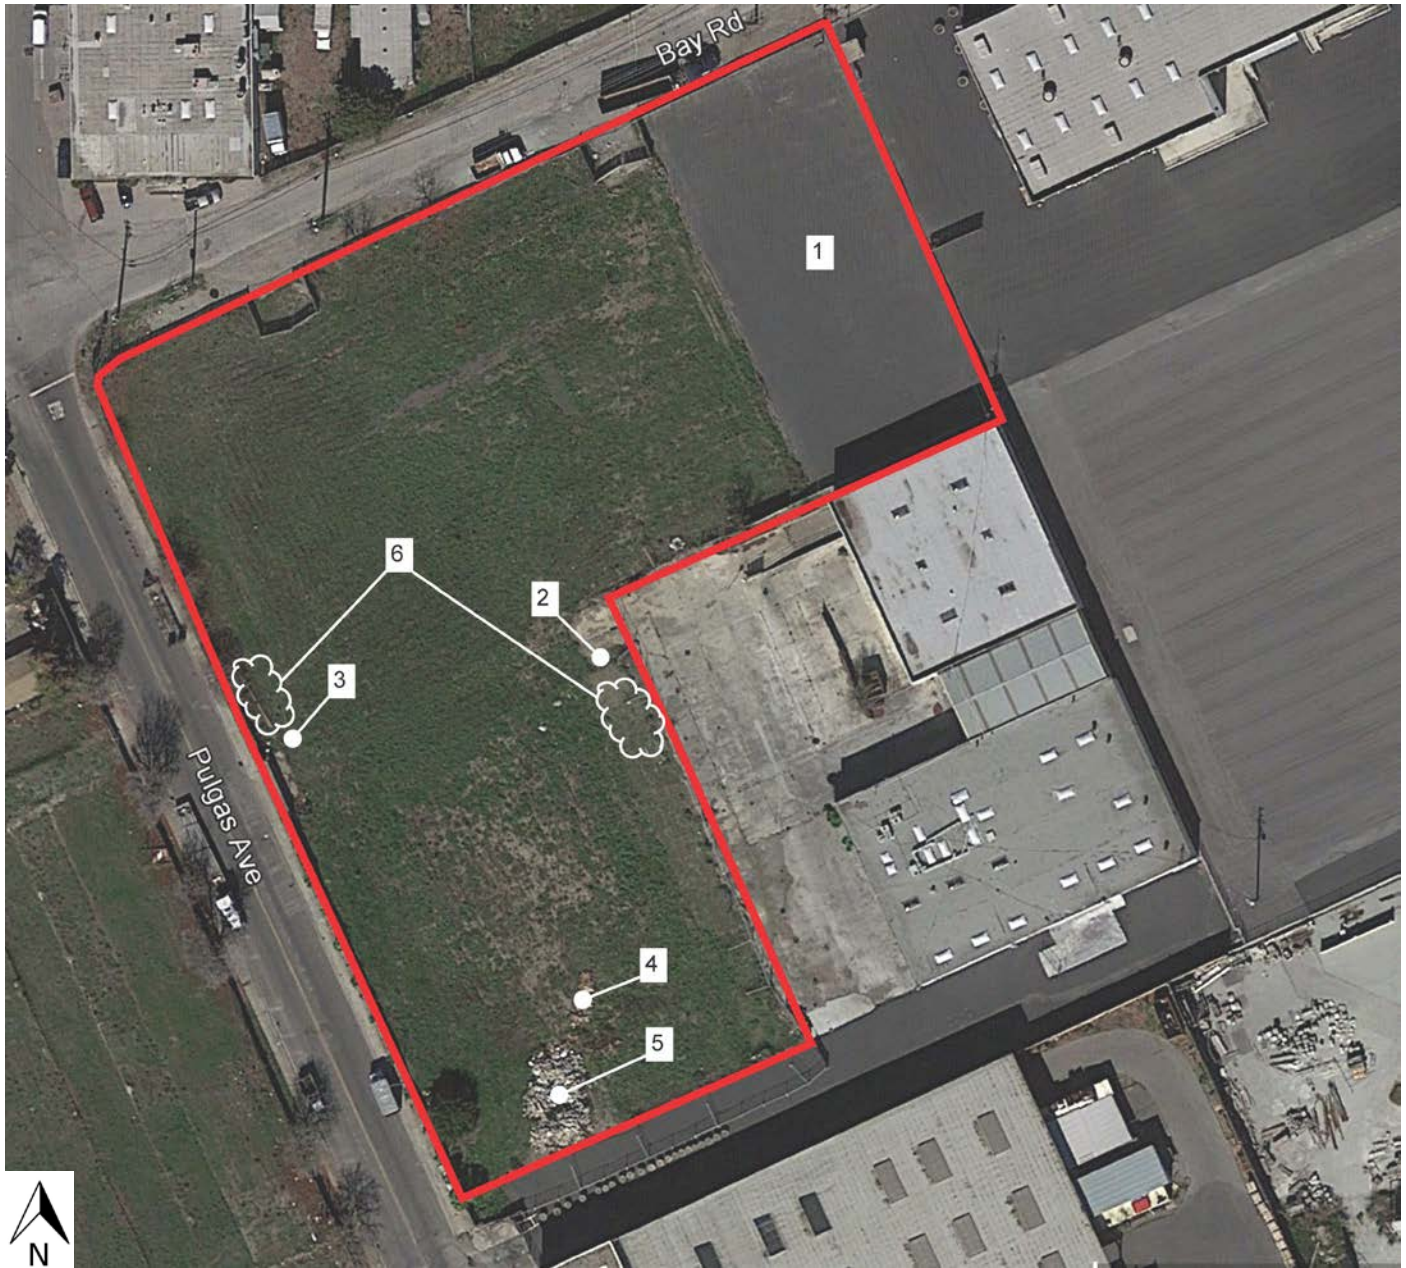
- Approximate Site Boundary
- 1 - Asphalt Cap
- 2 - Approximate Location of Monitoring Wells
- 3 - 55-Gal Drum of Soil (Investigation Derived Waste)
- 4 - Approximately 4 CY Stockpile of Brick Debris
- 5 - Approximately 100 CY Stockpile of Concrete Debris
- 6 - Miscellaneous Debris and Refuse
